# A Healthy Coliban Catchment

Citizen Science Project

River Health Snapshot Report 2023

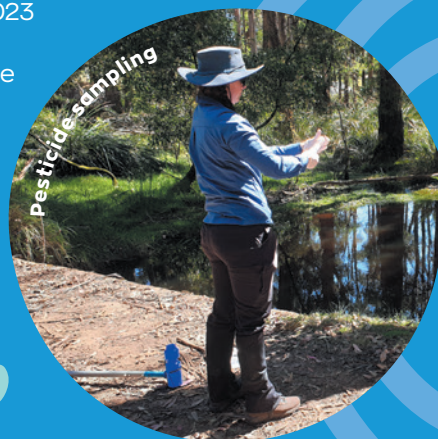
Within the Healthy Coliban Catchment project area, the Coliban River at Lauriston (NC\_COL380) was sampled for pesticides over six months between April and October. The graph below summarises the abundance of pesticides detected from water samples from this site over this period. The full report can be accessed here [https://www.nccma.vic.gov.au/sites/default/files/publications/pesticide\\_watch\\_2023\\_summary.pdf](https://www.nccma.vic.gov.au/sites/default/files/publications/pesticide_watch_2023_summary.pdf)
